Minutes of the Town of Farmington
Regular Town Council Meeting
June 23, 2015

FARMINGTON HIGH SCHOOL

FACILITY REPORT

EXECUTIVE SUMMARY

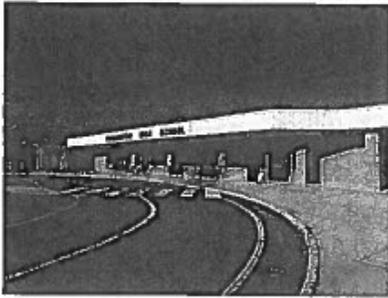
ABANDONED DROP OFF ZONE AND CAFETERIA

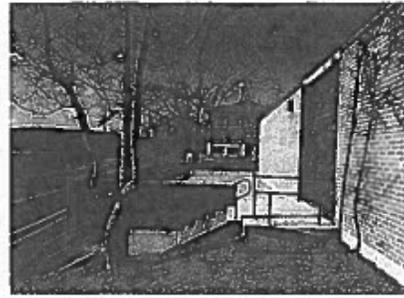
SITE STAIRS - HANDRAILS NOT CODE
COMPLIANT

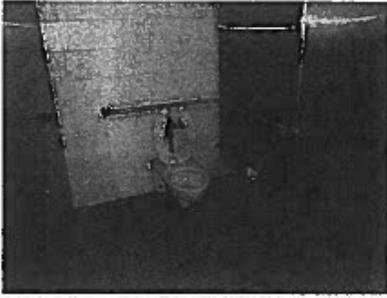
ACCESSIBLE TOILET IS NOT COMPLIANT WITH ADA REQUIREMENTS

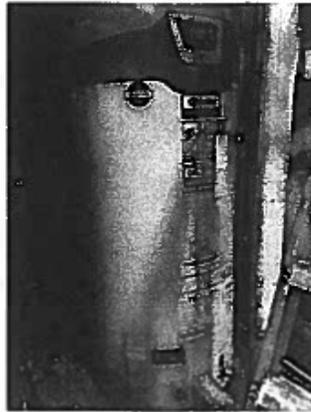
P-3 CONDENSING GAS FIRED WATER HEATER
