Minutes of the Town of Farmington
Regular Town Council Meeting
June 23, 2015

FARMINGTON HIGH SCHOOL

FACILITY REPORT

EXECUTIVE SUMMARY

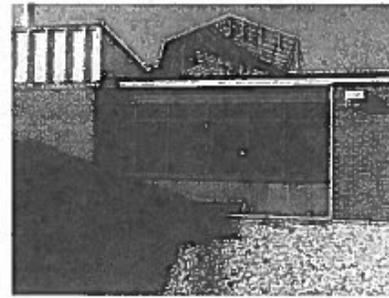
GREENHOUSE 700 WING - NOT ACCESSIBLE

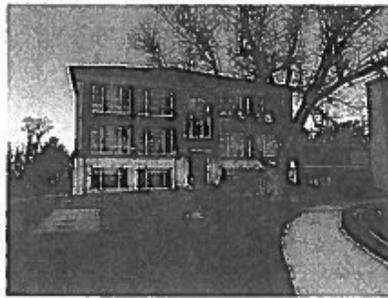
EXIT FROM STAIRWELL NON-ADA COMPLIANT

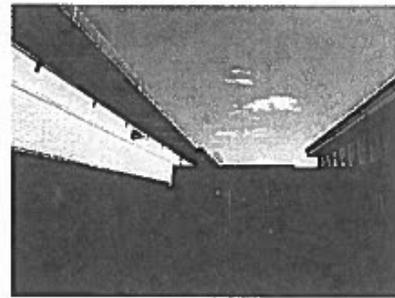
NON-COMPLIANT WOOD STAIRS
AT ROOF

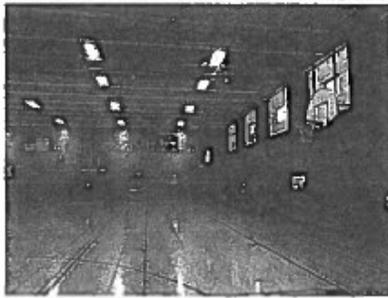
Exterior windows, both fixed and operable, have been renovated or replaced with aluminum or hollow metal double pane glazing in the majority of the campus. Notable exceptions are the glass block in the 1952 gymnasium, projecting window boxes at the library mezzanine, and exterior stairway doors at the original 1928 three story building which are still of original vintage. The windows in the 2004 900 block and the retro-fitted single hung windows in the three story portion of the 1928 100-block wing are double glazed, but were not confirmed to be thermally-broken. (Thermally broken windows have built-in insulating blocks to prevent conductivity of heat and cold.) Aluminum framed retrofitted windows in the 1928 structure were reportedly replaced in the 1990's and are of inferior quality, are very drafty, have no insect screening, and are difficult to operate.

ORIGINAL 1952 GYMNASIUM WITH
GLASS BLOCK WINDOWS

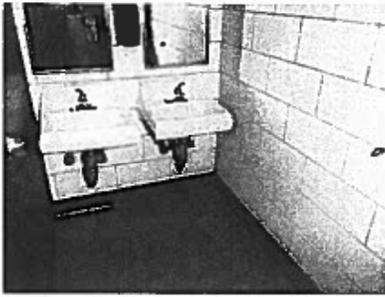
TYPICAL BATHROOM LAVATORIES NOT ADA COMPLIANT

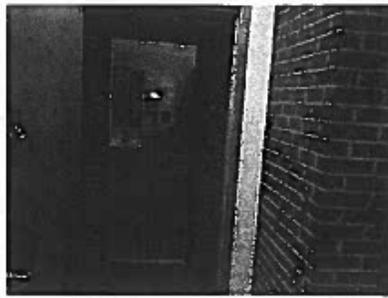
BATHROOM - APPROACH NOT ACCESSIBLE

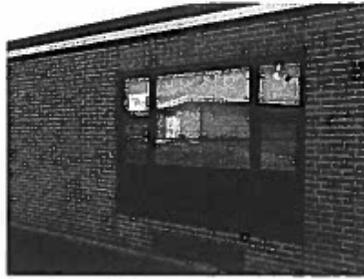
beneath grade. Air intakes for through-wall mechanical units in these rooms are located at grade potentially exacerbating the amount of moisture within these spaces. Although there may be additional causes to indoor air quality issues these are the most likely probable causes, to more thoroughly determine causes of moisture/ dampness destructive testing and investigations should be performed.

WINDOW & AIR INTAKE

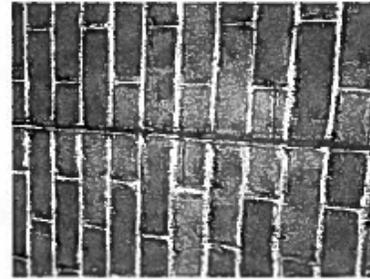
TYPICAL MASONRY EXPANSION JOINTS

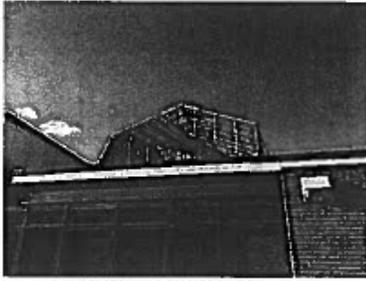
GREENHOUSE 700 WING - NOT ACCESSIBLE

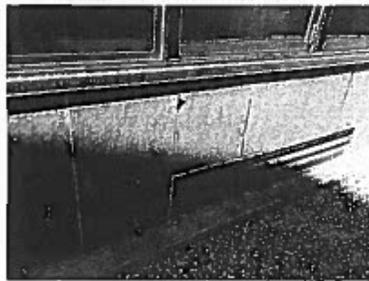
SLATE UNDER WINDOW, CONDENSATE DRAIN

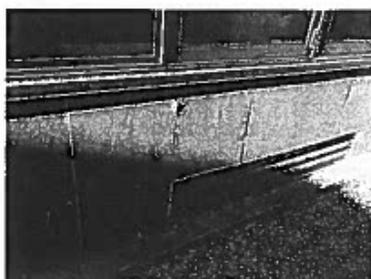
SLATE UNDER WINDOW, CONDENSATE DRAIN

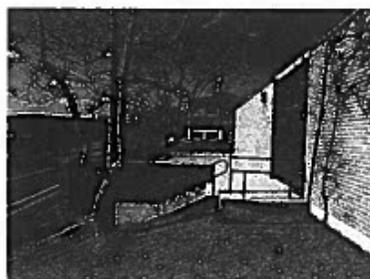
SITE STAIRS - HANDRAILS NOT COMPLIANT

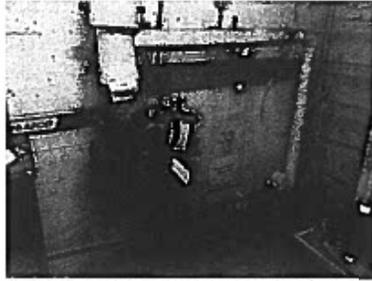
P-1 BUILDING 2B DOMESTIC WATER ENTRANCE

at this location includes a water meter, back flow preventer, and isolation valves. Due to the first service being original to the building it should under this project be demolished and replaced with new. The 900 wing service is in good condition with the exception of breeches in the insulation; once these are fixed this service would be recommended to remain as it was installed when the 900 wing addition was constructed and is of adequate size to serve the current 900 wing plus an addition of decent size.

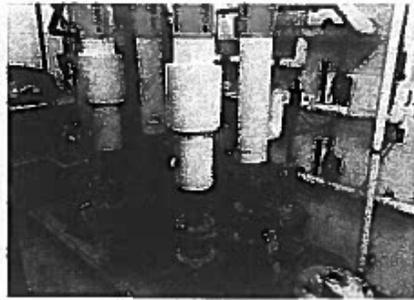
M-3: 500 WING BASE MOUNTED PUMPS

2. The 500 wing boiler room is located behind the shop areas, this room houses two (2) dual fuel fired Weil McClain hot water boilers (Photo M-2). These boilers are 19 years old. The burners currently receive make up air via a sidewall mount mechanical make up air louver which is interlocked to run during burner operation. There are currently two base mount pumps (Photo M-3) which flow heating hot water to several unit ventilators, air handlers and variable air volume boxes located in the 500 and 700 wings. In addition each of the boilers has a dedicated in line pump to assure minimum flow through the boilers while firing. While the boilers and burners are expected to have an existing life remaining of approximately 11 years, reuse of the boilers in a new building design would not be recommended due to new higher efficient, more reliable technologies along with the fact reuse would not comply with renovate to new status is desired.

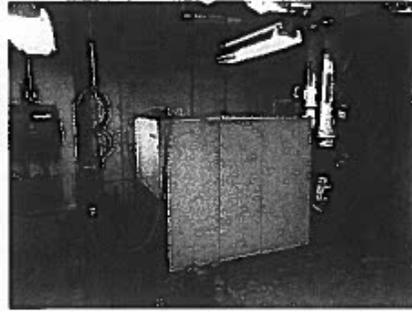
M-4. 900 WING DUAL FUEL BOILER

3. The 900 wing boiler room is located behind the locker room area in this wing, this room houses one (1) dual fuel fired DeDiteich hot water boiler (Photo M-4). This boiler is 12 years old. The burner currently receives make up air via a sidewall mount mechanical make up air louver which is interlocked to run during burner operation. There are currently two base mounted pumps which flow heating hot water to an air handler and several variable air volume boxes located in the 900 wing. In addition the boiler has a dedicated in line pump to assure minimum flow while firing. While the boilers and burners are expected to have existing an life remaining of approximately 18 years, reuse of the boilers in a new building design would not be recommended due to new higher efficient, more reliable technologies along with the fact reuse would not comply with renovate to new status is desired.

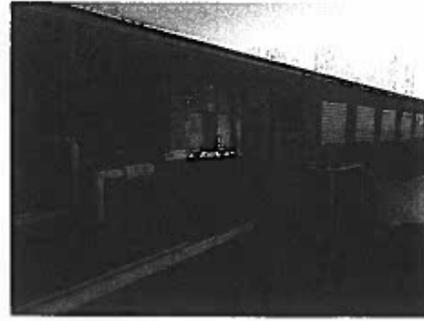
M-5: ROOF MOUNT AIR COOLED CHILLER

1. The building is currently served by chillers located in (2) two different locations. The first of the two is located above the principal and nurses suite on the roof, this chiller is an air cooled chiller (M-5) manufactured by Carrier with integral pumps. The chilled water piping leaves the chiller and is routed on the roof ultimately entering two mechanical spaces which contain air handlers that serve the auditorium and band room. This chiller was installed 7 years ago and appears to be in good condition. While the chiller is expected to have an existing life remaining of approximately 12 years, reuse of the chiller in a new building design would not be recommended due to non-compliance with renovate to new status.

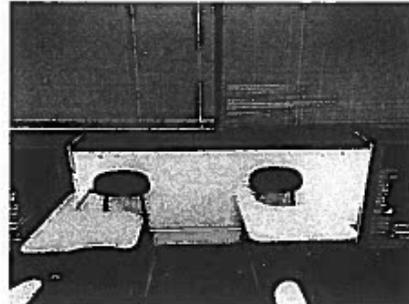
M-8 UNIT VENTILATOR

b. The second are unit ventilators (Photo M-8) (in the classrooms and facility planning space) which provide conditioned air to the spaces; each unit ventilator has a steam coil within it that heats the space. Outside air for ventilation is provided to the unit ventilators via wall mounted louvers behind each unit ventilator. It should also be noted that the facility planning space unit ventilators have had refrigerant coils added for cooling, the split condensing units for these coils are located on the roof above, other classrooms in this wing have no cooling.

d. All mechanical equipment in the 800 wing is not recommended for reuse in a new building design due to the reuse not complying with renovate to new status and noise concerns associated with the unit ventilators, this wing being provided with new mechanical systems could also lead to a large amount of energy savings.

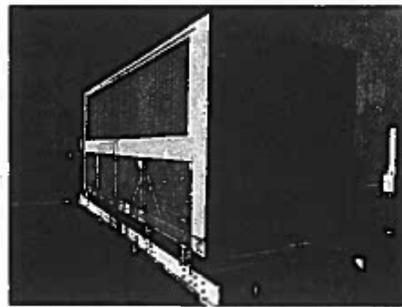
M-10: 500 WING ROOFTOP UNIT

a. The first is a rooftop air handler (Photo M-10) which provides conditioned (heated and cooled) air to variable air volume boxes which serve the classrooms. The air handler has a heating hot water coil which receives hot water from the 500 wing boiler room and a chilled water coil which receives chilled water from the chilled located below the lecture hall.

c. All mechanical equipment in the 500 wing is not recommended for reuse in a new building design due to the reuse not complying with renovate to new status.

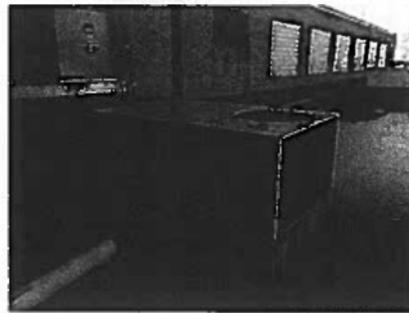
M-12. ROOFTOP UNIT

a. The first type of system is a rooftop air handler (Photo M-12) which provides conditioned (cooled) air to the spaces. The air handler has on board direct expansion cooling. The main source of heat for these spaces is wall mounted steam fin tube at the exterior walls. Steam is provided from the boiler room located below the principal/nurse suite. There is a dedicated rooftop unit for the principal's suite and a dedicated rooftop unit for the Main Office.

c. All mechanical equipment in this area while only 12 years old is not recommended for reuse in a new building design due to the reuse not complying with renovate to new status, this wing being provided with new mechanical systems could also lead to large amount of energy savings.
